City of Newport Beach

*A Presentation on Newport Harbor's Base Flood
Elevation (BFE)
&
Balboa Island Sea Wall Height*

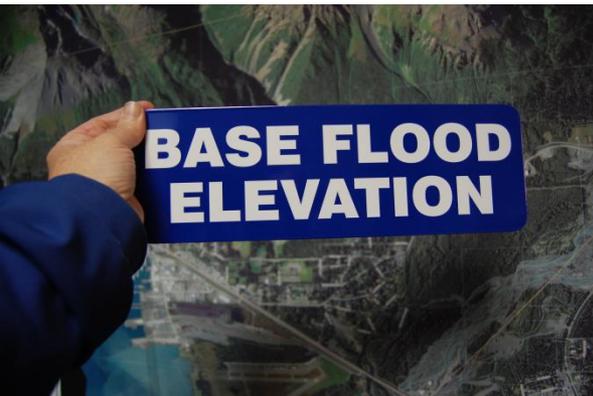
- Risk will be based on whether the property is above or below the Base Flood Elevation (BFE).
- Establishing the height of the BFE and the height of the property in reference to the BFE is critical.
- Current Base Flood Elevation is 9.0'.

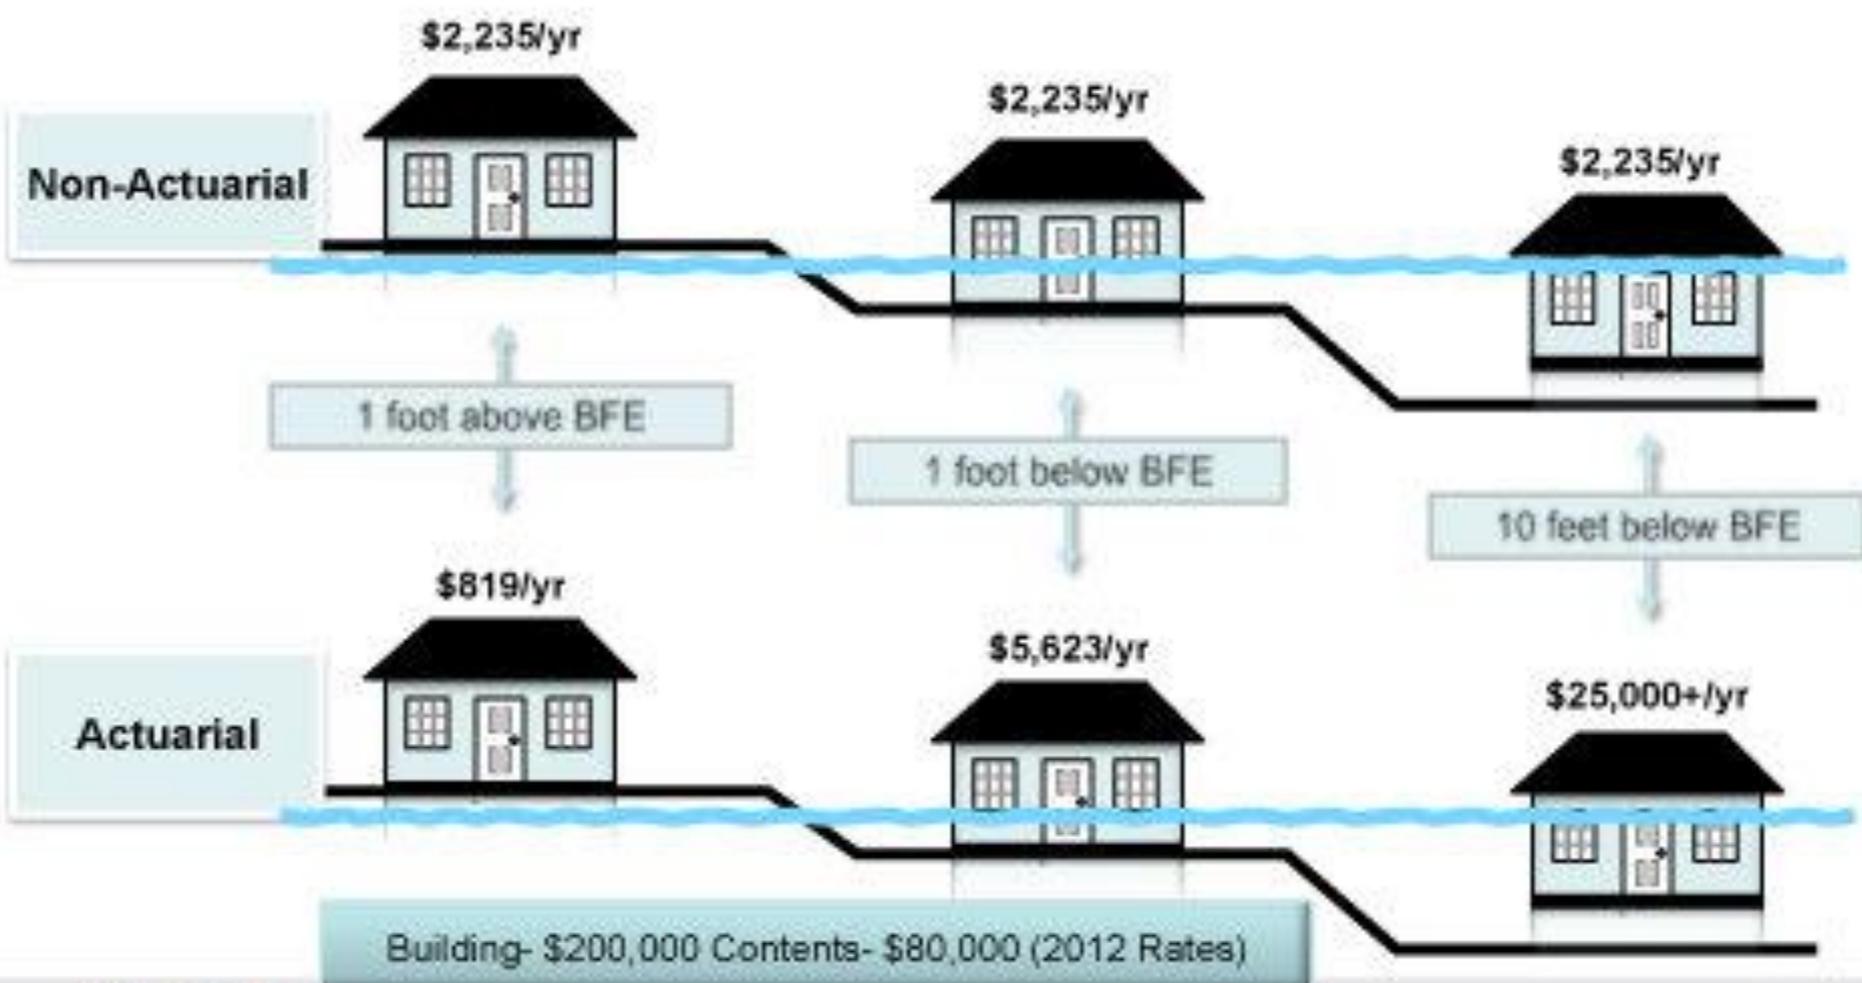
NFIP Rating Examples: The Impact of Loss of Subsidies

Rate comparisons

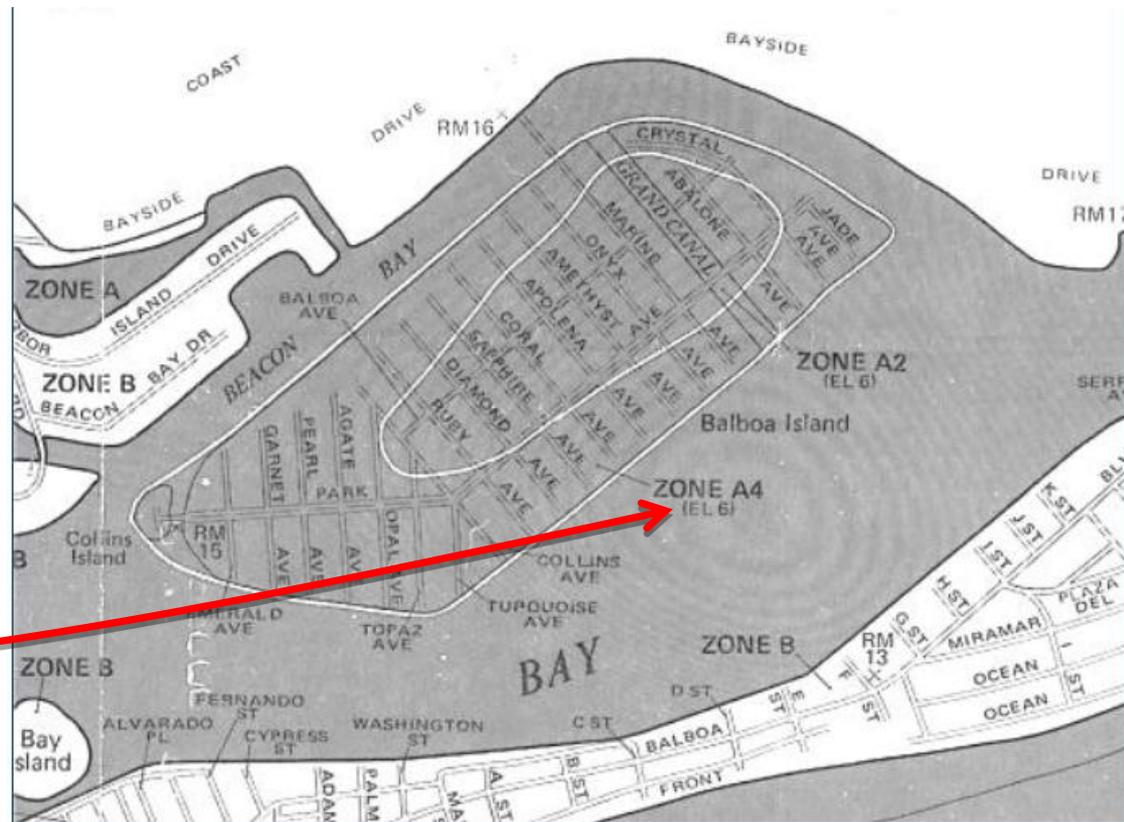
- ❖ Determine if FEMA's BFE of 9.0' is correct?
- 1978 The Flood Map showed a Base Flood Elevation of 6.0' **NGVD29**.

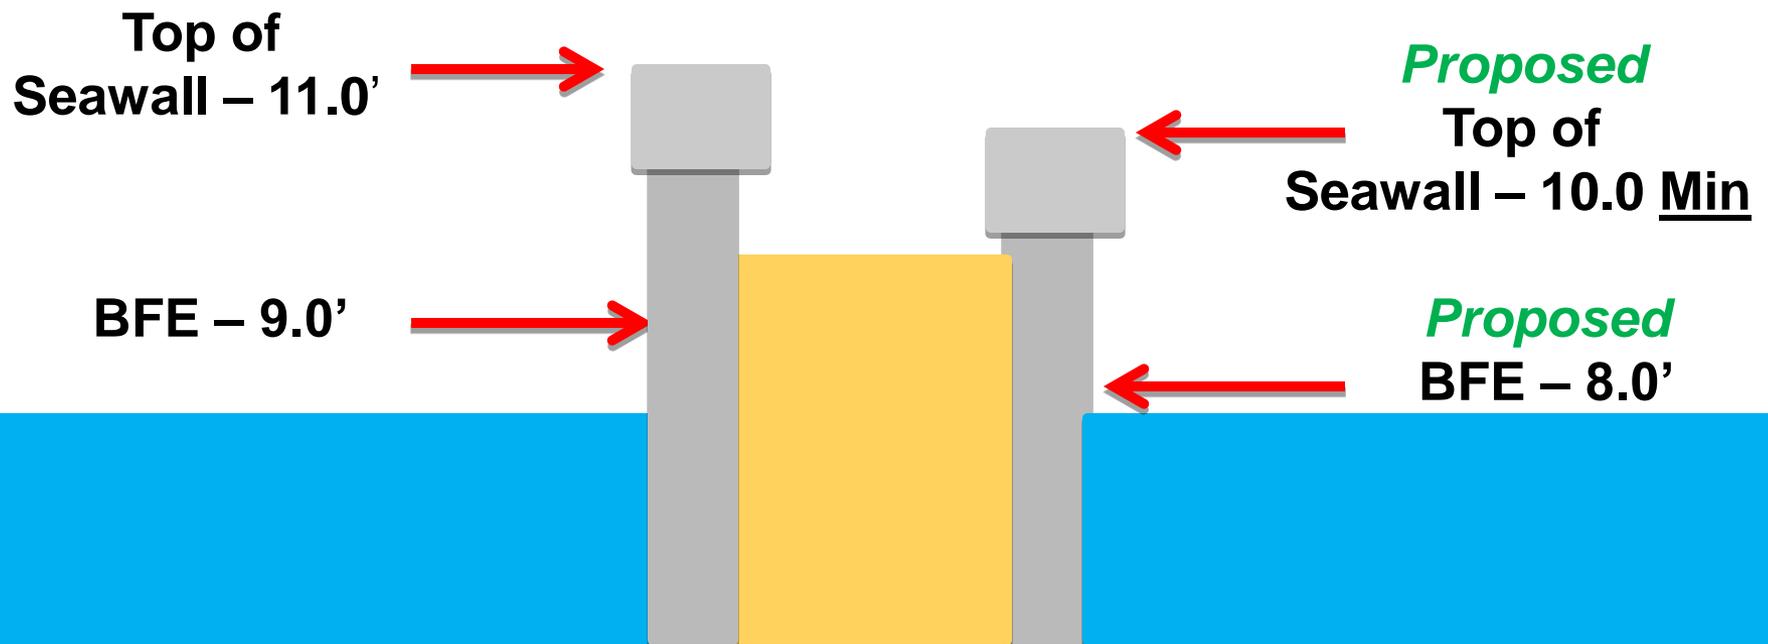
Seawall Height

- To be considered as a coastal levee, a 2-foot freeboard is required on the seawall.

- ◆ Island Removed from prior FEMA Flood Plain with Seawall Elev. = 10.0'
(Stillwater Elev. of 8.0' + 2.0' of Freeboard)
- ◆ Base Flood Elevation Determined by Drainage System—100 Year Storm Water Elevation.
- ◆ Adjacent Grade of Structure must be above 100 Year Storm Water Elevation to be out of the Flood Plain and will pay a lower Flood Insurance Rate.

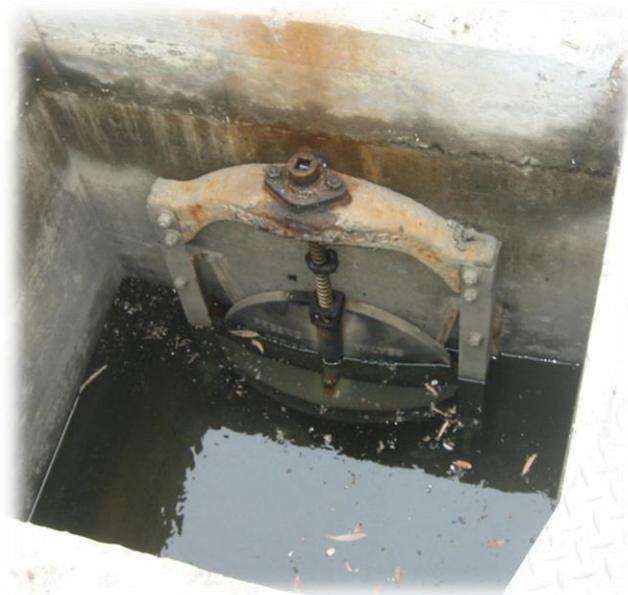
Protects the Island from Flooding due to High Tides
Currently Manually Operated

Manually Operated
with Valve Key

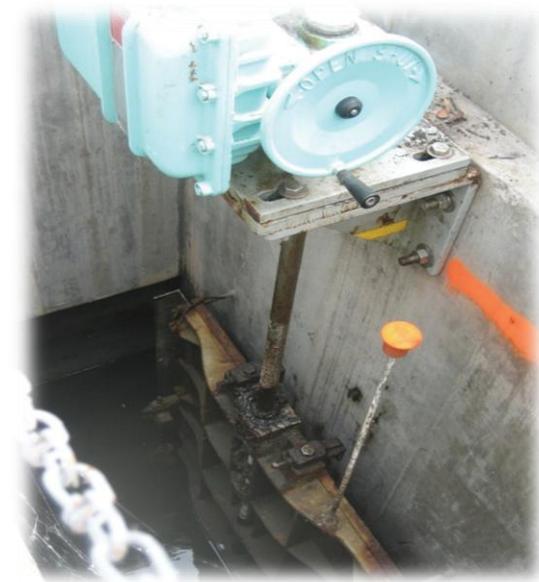
Power Assisted with
Manually Operated Up/Down Switch

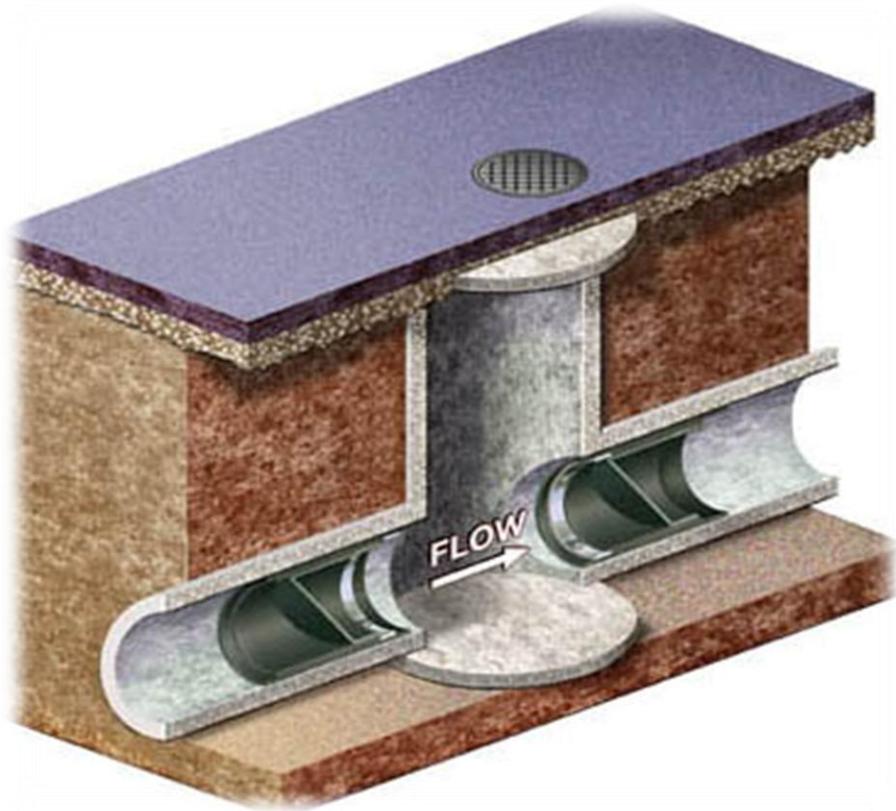
New Rubber Tide Valve (Check Valve)

- No Moving Mechanical Parts - Silent, Non-Slamming
- Non-Corrosive - Durable Rubber Construction
- Minimal Maintenance and Periodic Inspection Needed
- Around 1" of Water Pressure Opens Valve helping Eliminate Standing Water
- Simple Installation. Estimated 25-Year Life

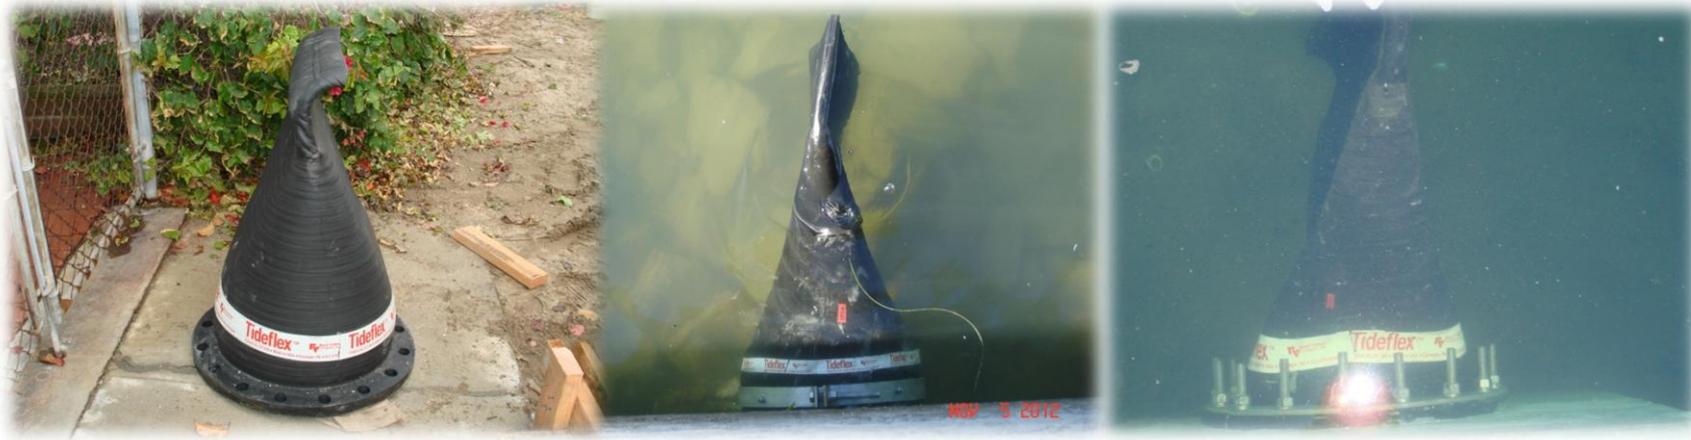
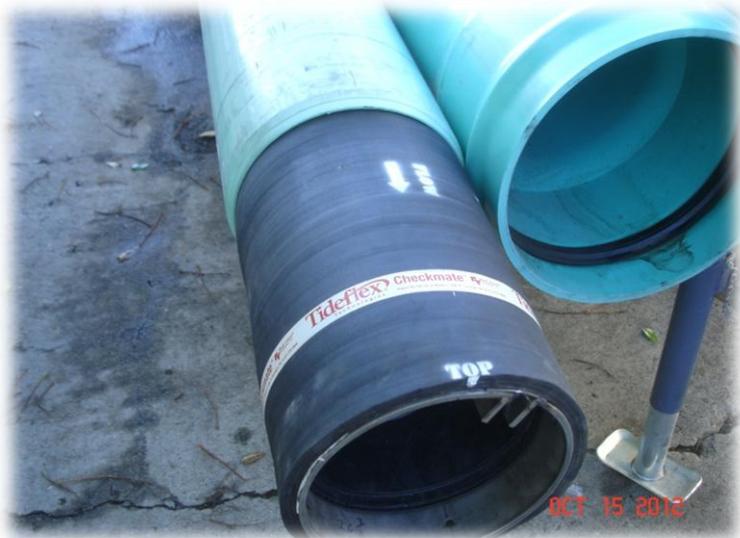
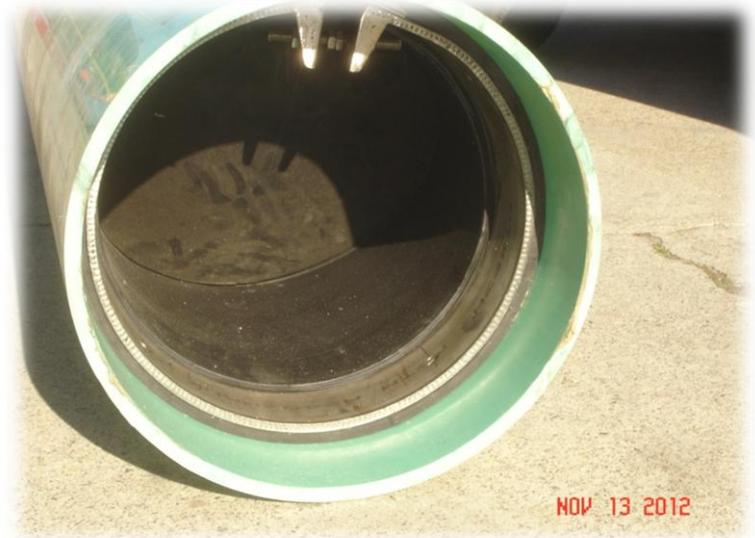
New Rubber Tide Valve (Check Valve)

Low Flow Open

Full Flow Open

Closed Against Tide

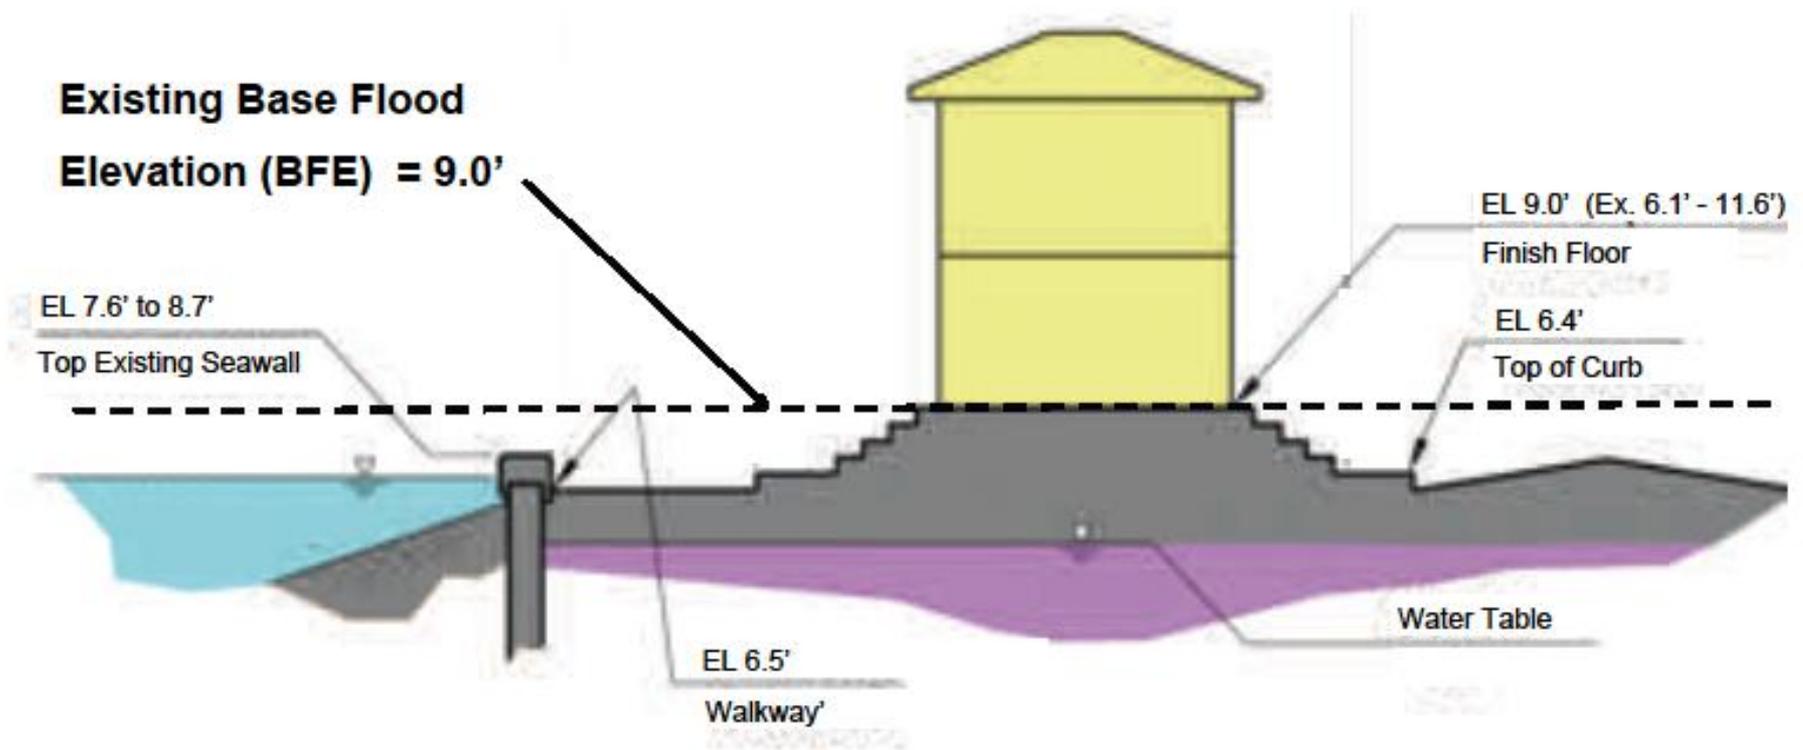
Existing Island Seawall and Flood Protection Conditions

- Existing FEMA Base Flood Elevation = 9.0' (NAVD 88)
- Finish Floor's at or above 9.0' will pay a lower Flood Insurance Rate.
- Finish Floor's below 9.0' will pay a higher Flood Insurance rate..

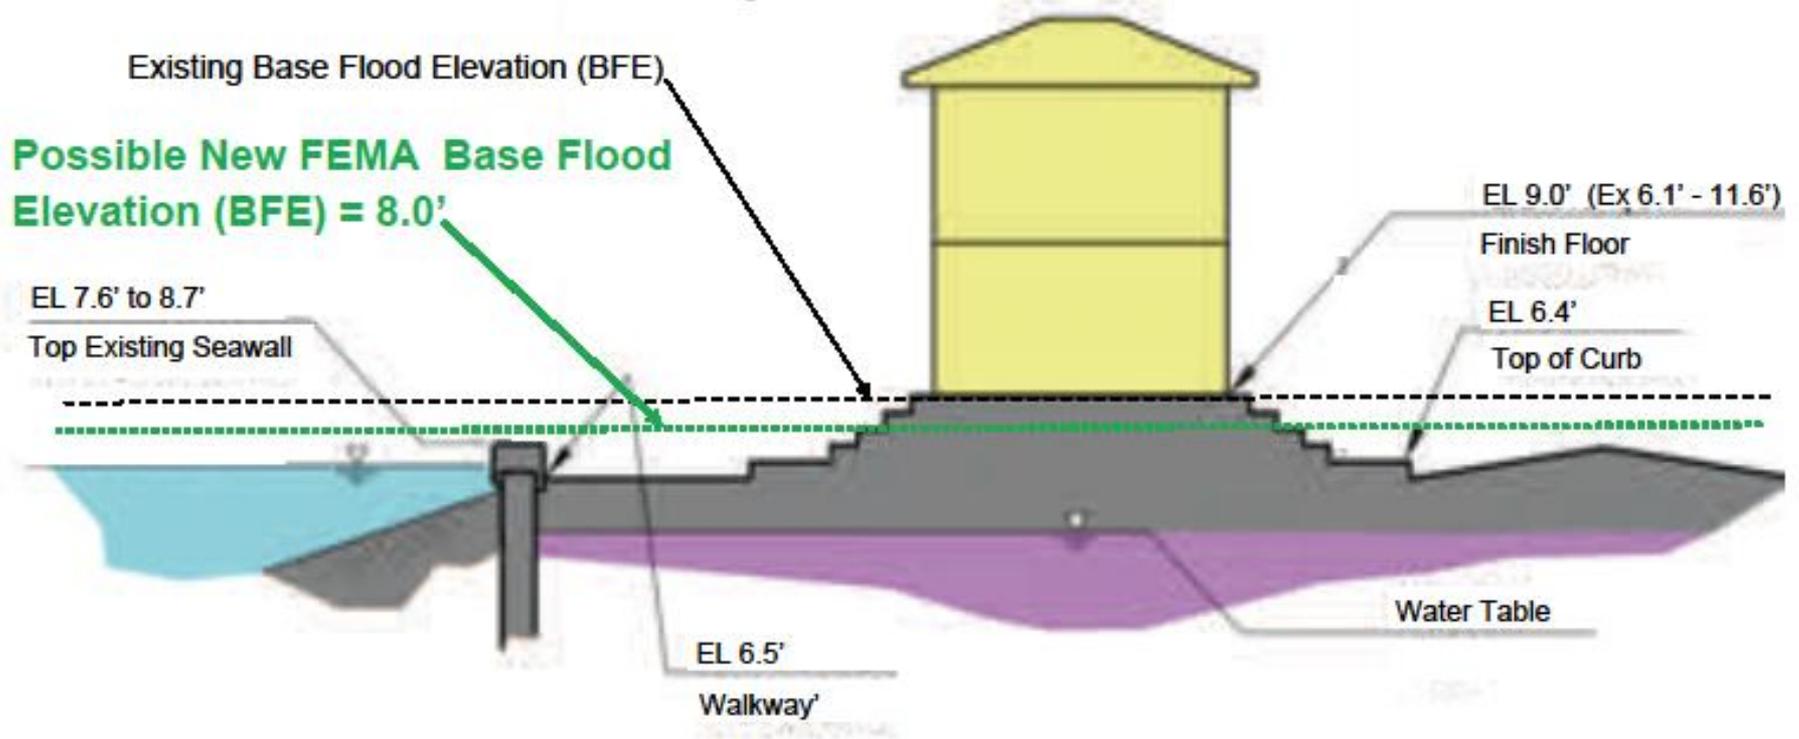
Existing Island Seawall and New FEMA Base Flood Elevation

- ◆ Possible New FEMA Base Flood Elevation = 8.0' (NAVD 88)
- ◆ Requires Letter of Map Revision (LOMR) by FEMA
- ◆ Finish Floor's at or above 8.0' will pay a lower Flood Insurance Rate.
- ◆ Finish Floor's below 8.0' will pay a higher Flood Insurance Rate.

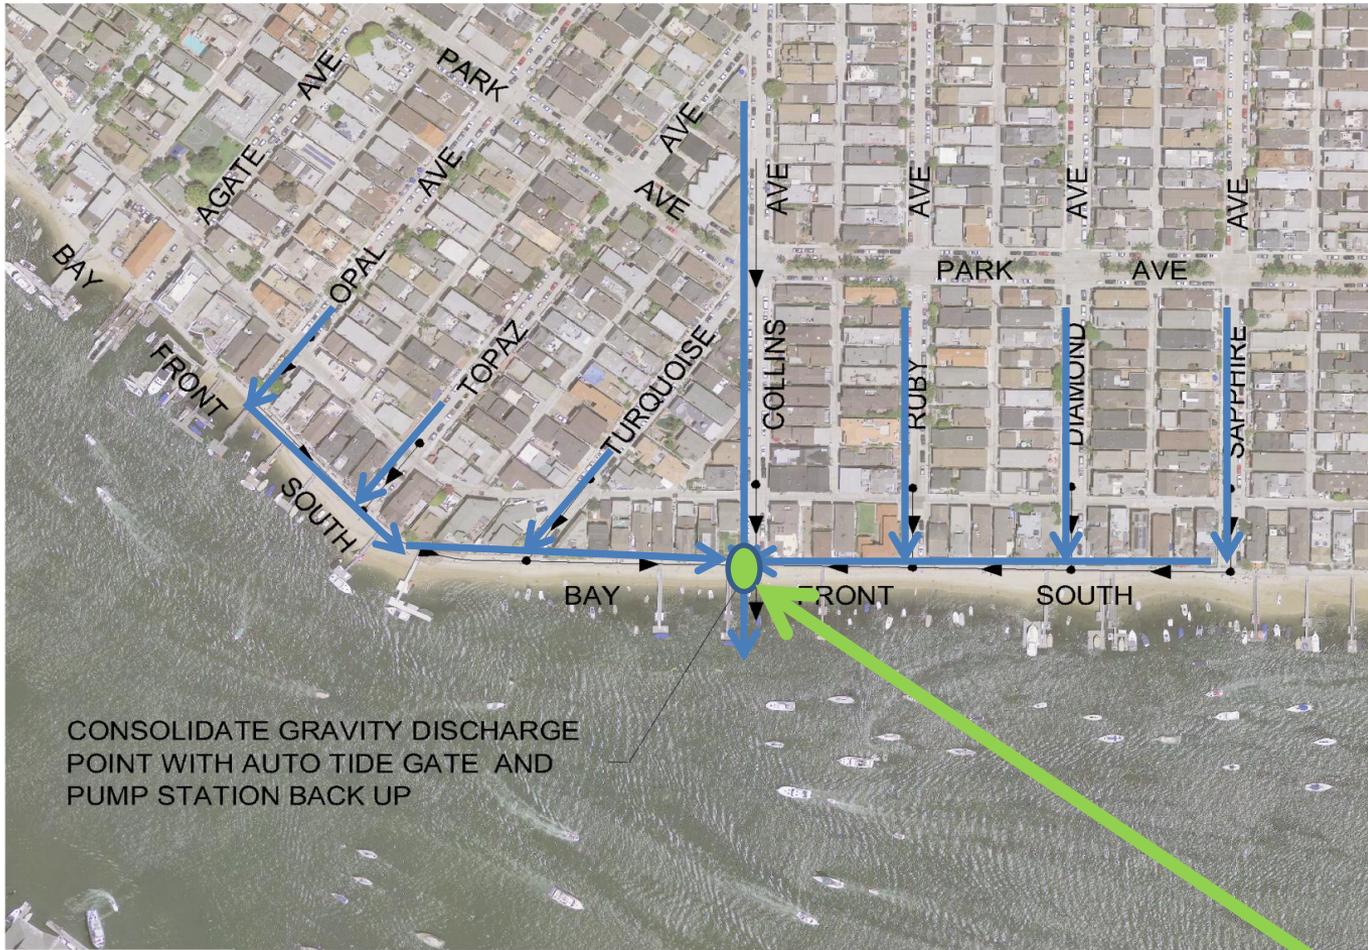
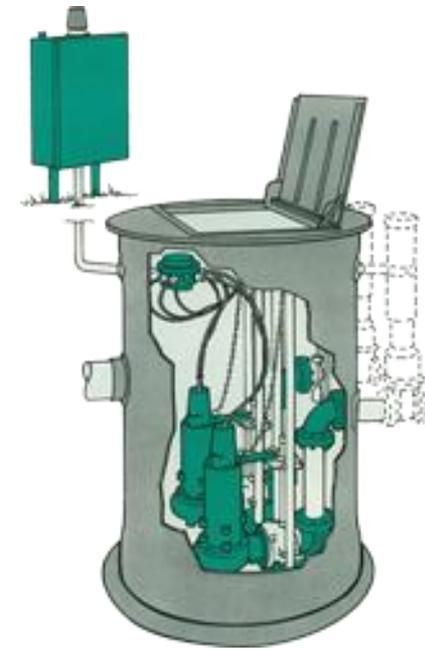
NEW DRAINAGE SYSTEM CONCEPT

- Reduce Number of Discharge Points
- Automate Tide Values
- Provide High Water Pump-Out Capacity

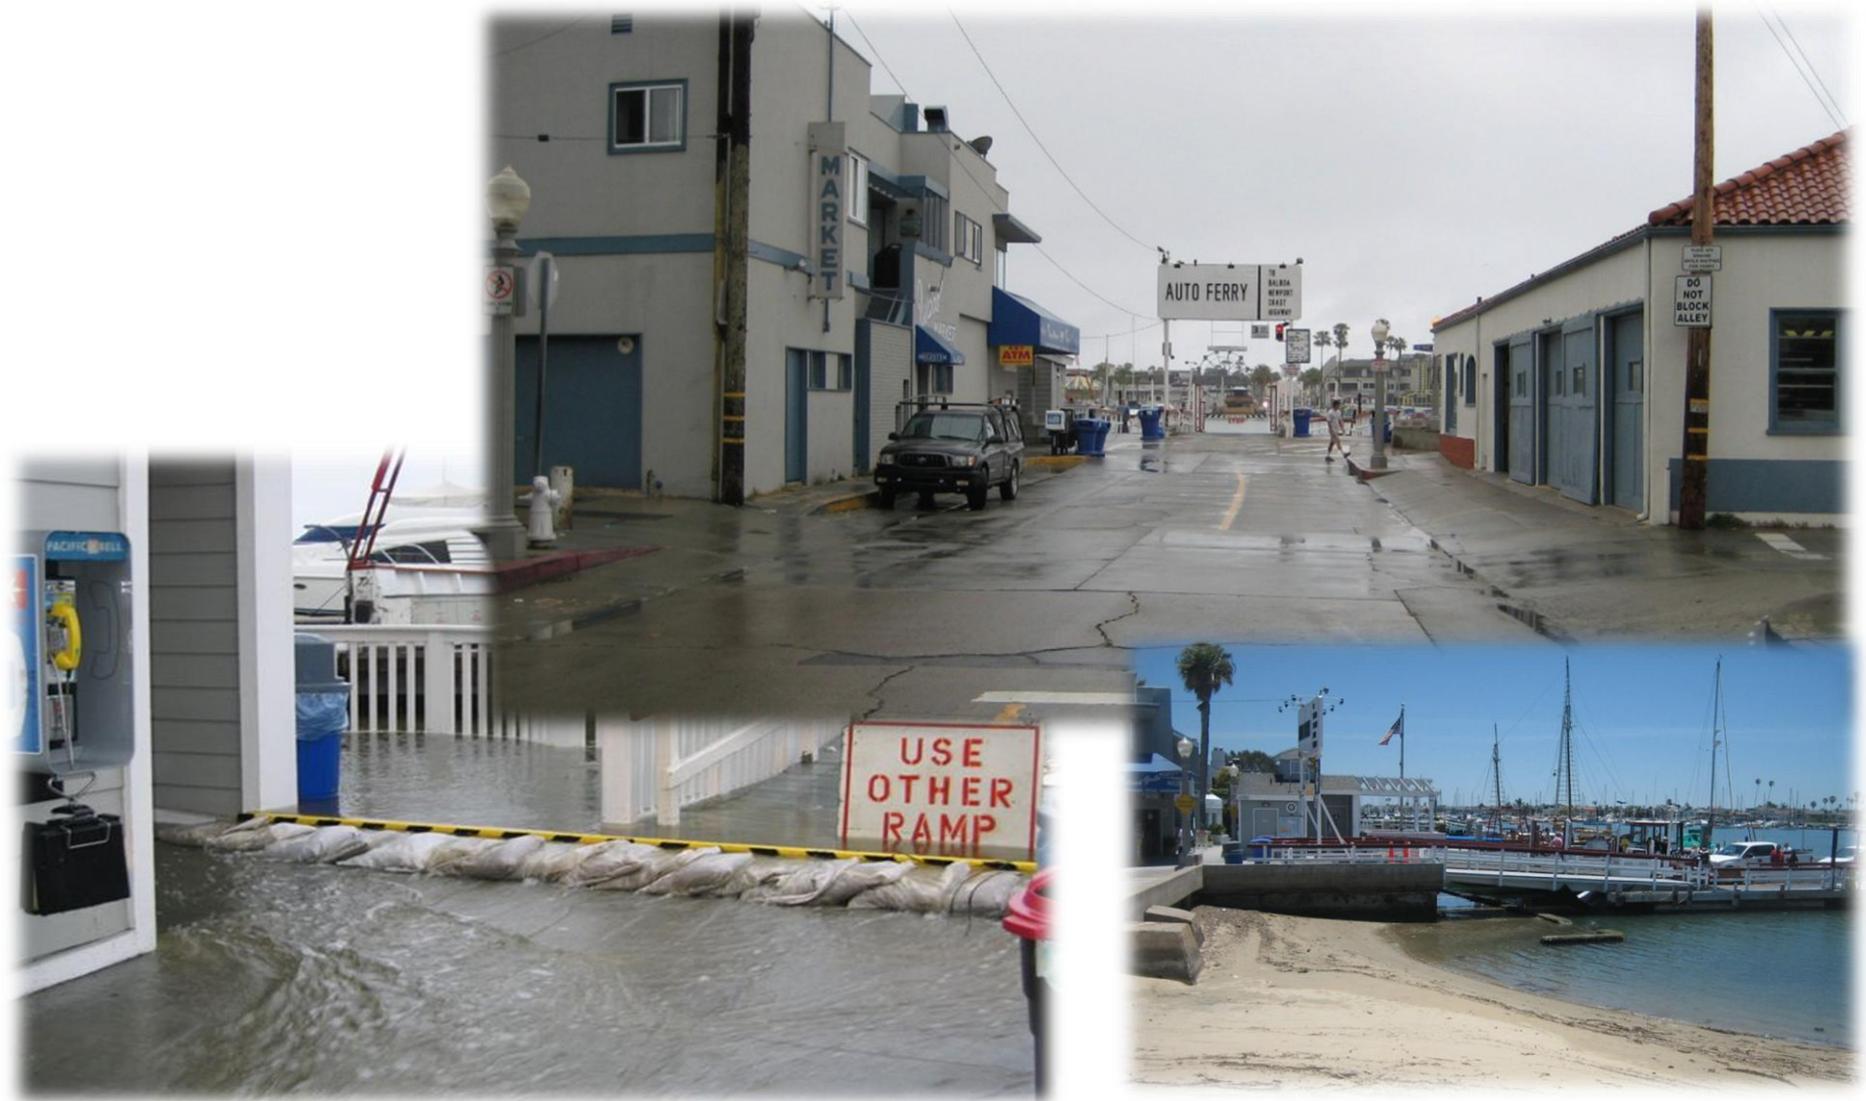
Sub-Terrain
Storm Water
Pump Station

Will also Need to Develop Acceptable Flood Proof Solution for Ferry Landing
